Please file the 2019 comprehensive condition assessment on the Bipole I and II valves and controls referenced in Appendix 7.7 (p. 9, lines 10-12).

**NELSON RIVER BIPOLES I AND II — CONDITION ASSESSMENT OF
THYRISTOR VALVES AND CONTROLS**

DATE: November 06, 2019

REPORT NO: TAM/ER – 2019/02

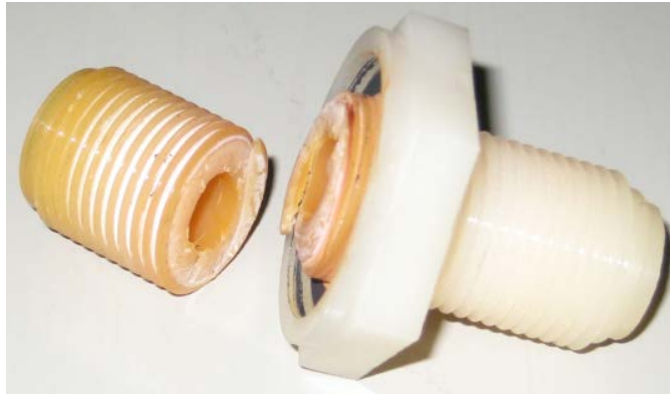
In addition to numerous forced outages, DIW leaks also caused two catastrophic flashover incidents. The first incident occurred on January 14, 2009. A DIW leak due to a broken 12/10mm plastic connector (see Figure 3.2) caused a flashover in a valve tower in VG42 at Henday and blew up a light-guide channel and damaged the fiber optic light guides inside (see Figure 3.3). Fortunately, the flashover did not cause fire and smoke damage. Discoloration of the connector is an obvious sign of ageing as shown in Figure 3.2. The second incident occurred in VG32 at Henday on December 04, 2011 also due to a 12/10mm connector failure, but its consequence was much more severe as shown in Figure 3.4 (see [9] for more details). The resulting fire/arc burnt half of a light guide channel and 50% of the light guides inside. The thyristor pairs in three modules were short-circuited. The resulting smoke and debris did not only severely contaminate the valve tower where the flashover took place, but also contaminated other valve hall components. It took 13 days to clean and repair the damaged/contaminated valves. We barely managed to repair the damaged light guide channel with deviations from the original installation due to a shortage of spare parts and materials.

Figure 3.2. Broken 12/10 mm double-sided plastic connector as a result of aging.

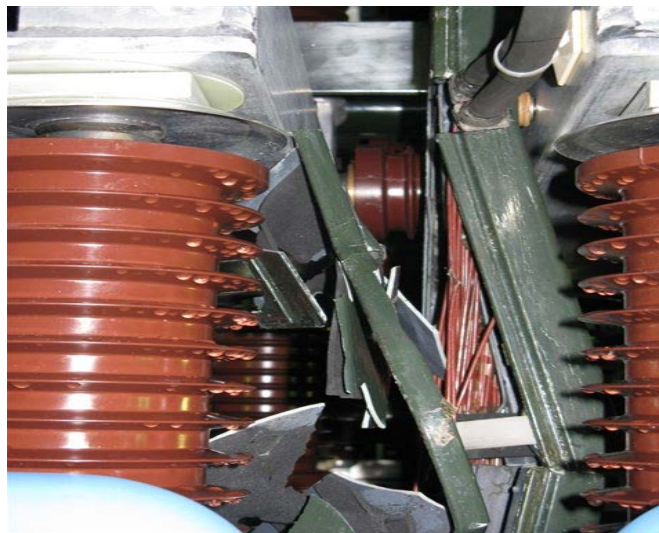
Figure 3.3. Damage caused by flashover due to a water leak in VG42 at Henday on January 14, 2009.

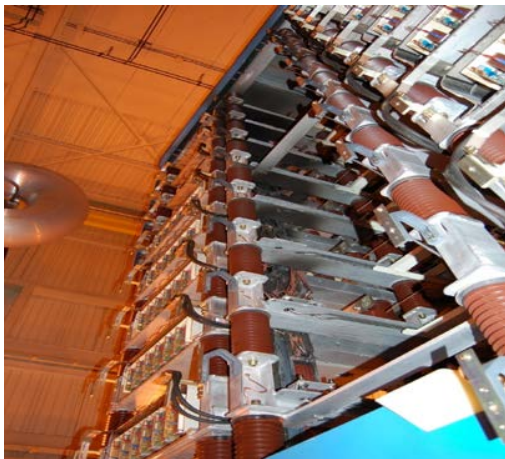
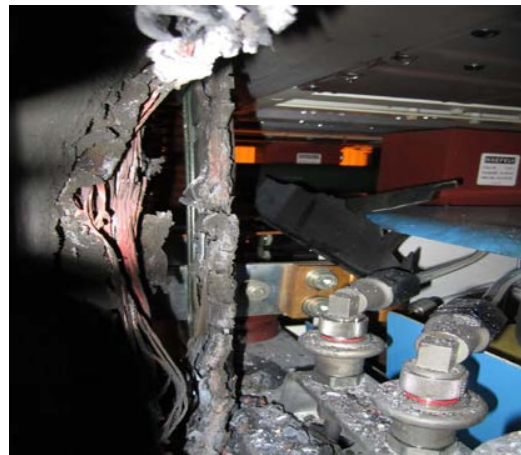
Figure 3.4. Damage caused by flashover due to a water leak in VG32 at Henday on December 04, 2011.

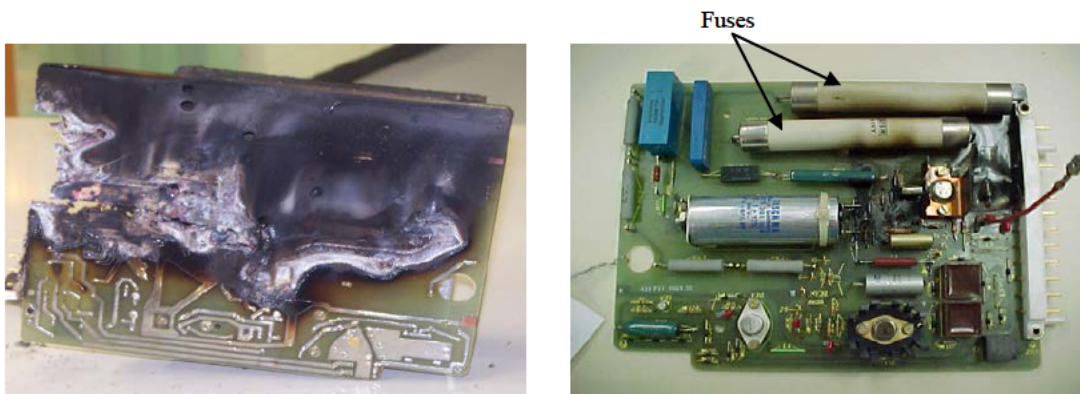
Starting from 1998, fire incidents frequently occurred in the valve hall as a result of SAB card failures. At least 23 fire incidents have happened over the past two decades. Some of the burnt cards are shown in Figures 3.6 and 3.7. In the initial incidents, fires always started in close proximity of the power inputs of S-cards.

Figure 3.6. S-cards damaged by fires.

A detailed investigation was carried out with the supplier's help. It was determined that the root cause of the fires was solder joint failure due to aging and vibration. Over the next 4 years, the joints near the power inputs of all S-cards were re-soldered (see A1 in Figure 3.8). Each VG had to be taken out of service for 2 weeks to complete the re-soldering work.

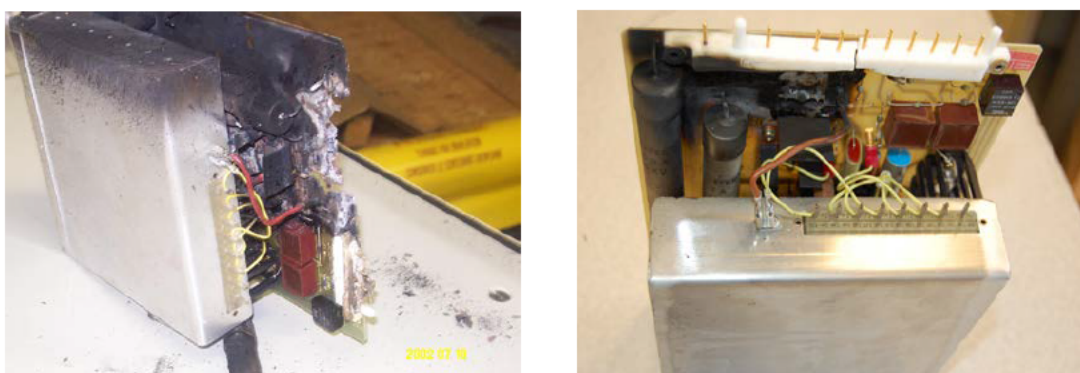
Figure 3.7. SAB cards damaged by fires.

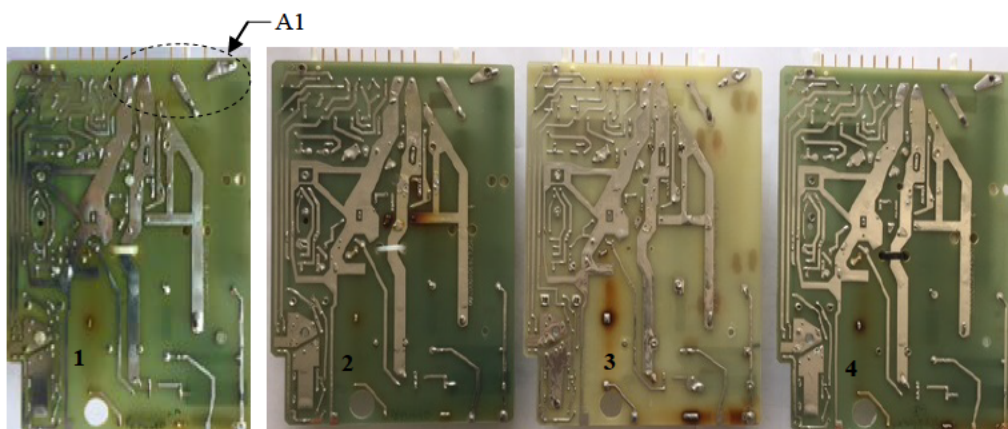
Recently, during SAB card repairs, it was found that an increasing number of SAB card faults have been caused by blown capacitors in A-cards.

As the SAB cards continue to deteriorate, the rate of SAB card failures and resultant risk of fires are expected to increase (see Section 3.1.8).

Figure 3.8. Aging S-cards. Card 1 is functioning. Cards 2 to 4 failed beyond repair.

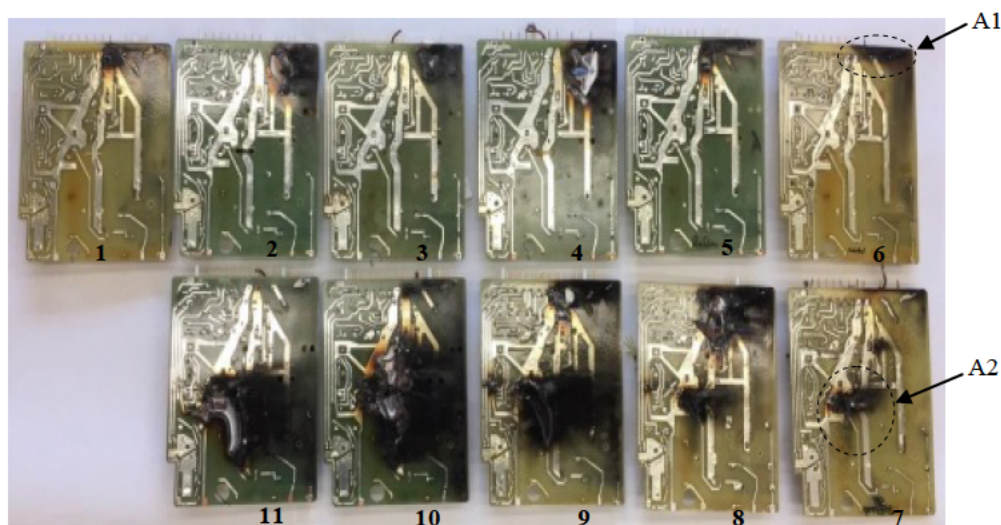
Figure 3.9. Burnt S-cards at Henday. Fires started in area A1 on cards 1 to 6, areas A1 and A2 on cards 7 to 10, and area A2 on card 11. S-cards were re-soldered only in area A1. Fires occurred on cards 5 to 7 that had been re-soldered.

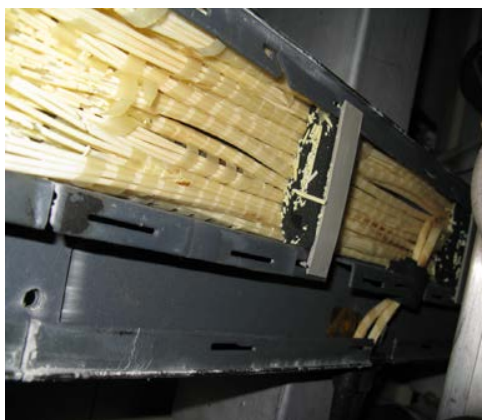
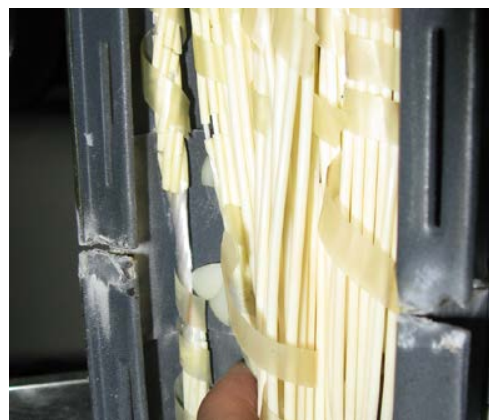
It was found that the light guides in the 250kV valve groups (VG31 & VG41) had deteriorated to such a degree that their insulation jackets had cracked and broken off, leaving numerous sections of glass-fibre without protection as shown in Figures 3.10(a) and (b). The associated LG channels have also severely deteriorated and suffered varying degrees of damage due to partial discharge and electrical tracking activities as shown in Figure 3.11. It seems that the damage had been done quite some time prior to 2009.

Figure 3.10(a). Severely deteriorated LG insulation jackets at Henday.

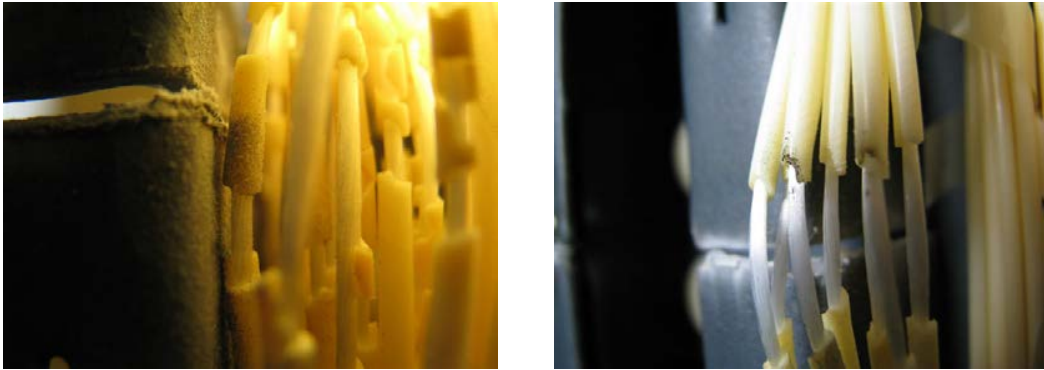
Figure 3.10(b). Severely deteriorated LG insulation jacket at Dorsey.

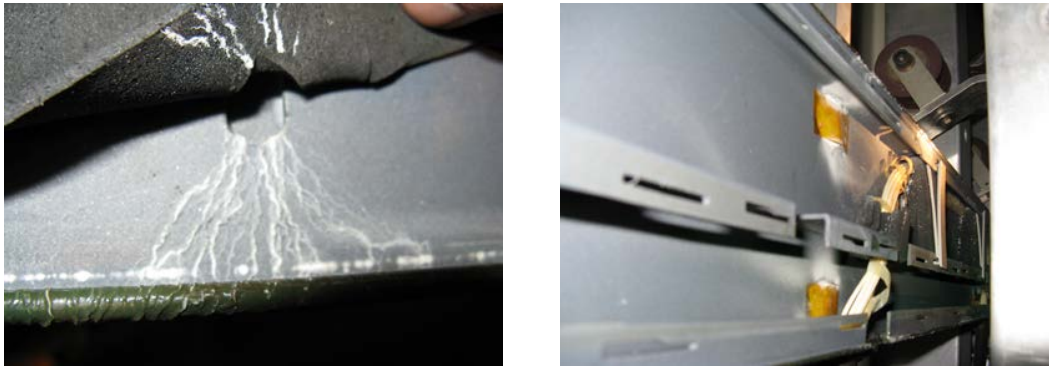
Figure 3.11. Damages caused by electrical tracking and partial discharge activities inside the LG channel.

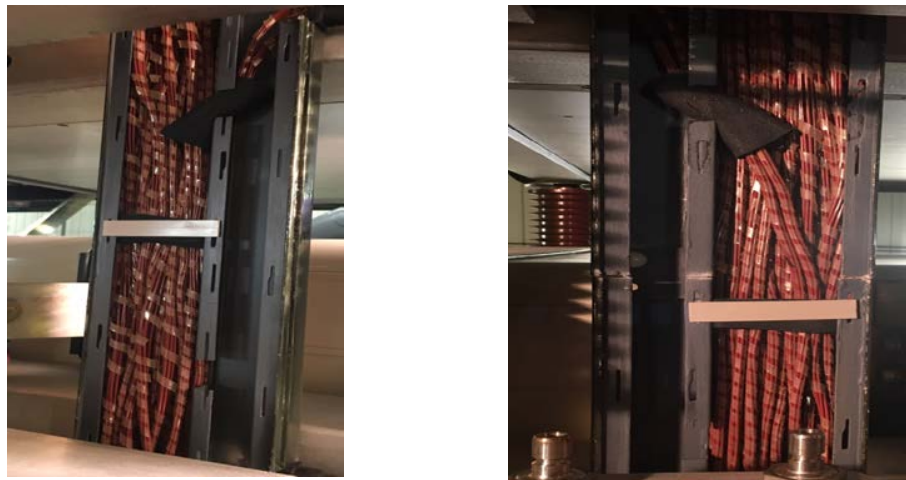
During the repair of the damage in the two flashover incidents described in Section 3.1.1, it was found that the light guides in the stage 2 VGs (VG32 and VG42) were in much better condition (see Figure 3.3). Their insulation jackets appear to be made from different material. The light guides in VG32 were inspected at Henday in 2009 and they all appeared to be in good condition at that time [14]. The light guides in two LG channels of VG42 were recently inspected at Dorsey and Henday, respectively. They appear to be in decent condition (see Figure 3.12).

Figure 3.12. Light guides in VG42 as of May 2019.

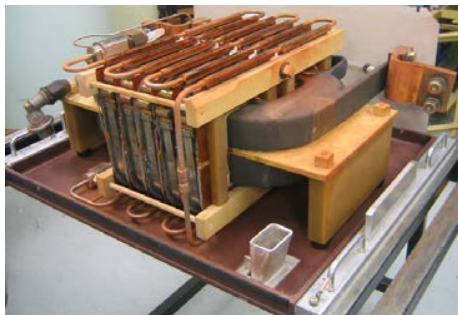
Since all the epoxy resin films have the same lifetime and are subjected to the same operating condition, it is expected that a similar condition would be observed for other reactors if they are disassembled.

The above facts indicate that the reactor modules in BP2 have a lifetime of approximately 30 years and all of them are in the wear-out state.

(a) Reactor module with red dust.

Figure 3.13. Failed reactor module originally installed.

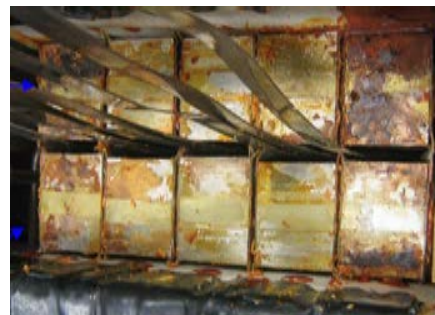
(b) Delaminated core parts.

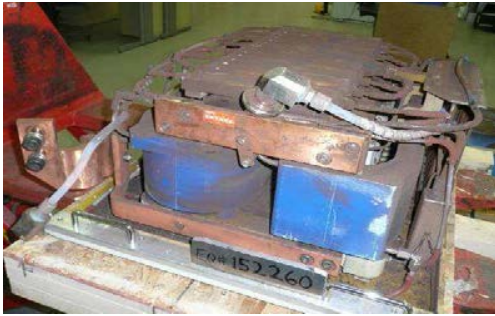
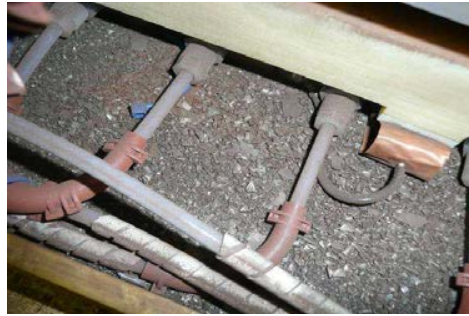
Figure 3.14. Failure of a replacement reactor module at Henday.

Twenty three (23) of them were installed in the BP2 valves in 2012, but failed only one year after being put in trial operation. On May 7, 2012, 11 of them were installed in VG31 at Henday. On April 23, 2013, VG31 was tripped on fire detection. It was found that one of them completely failed (see Figure 3.14). Other reactor modules were also starting to show a similar sign of failure. All of them were then removed from service. Twelve (12) replacement reactor modules installed at Dorsey also showed a similar sign of failure. i.e., red/brown dust on the module (see Figure 3.15). Analysis by Siemens indicates that the root cause of the failure was core delamination similar to the failure of the original reactor modules.

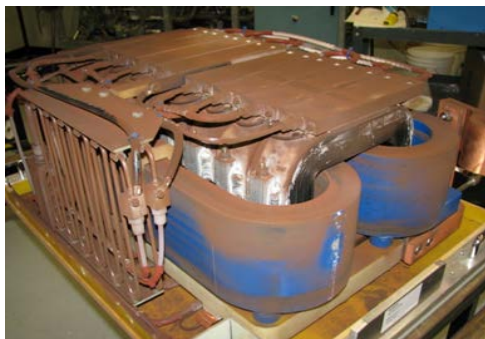
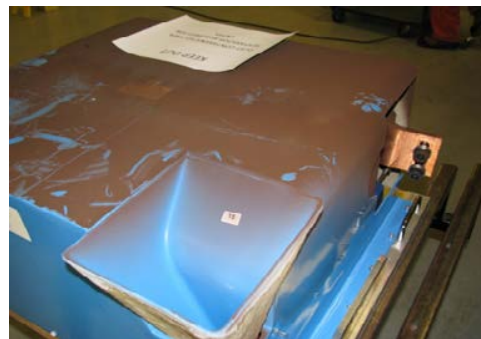
Figure 3.15. Failure of a replacement reactor module at Dorsey.

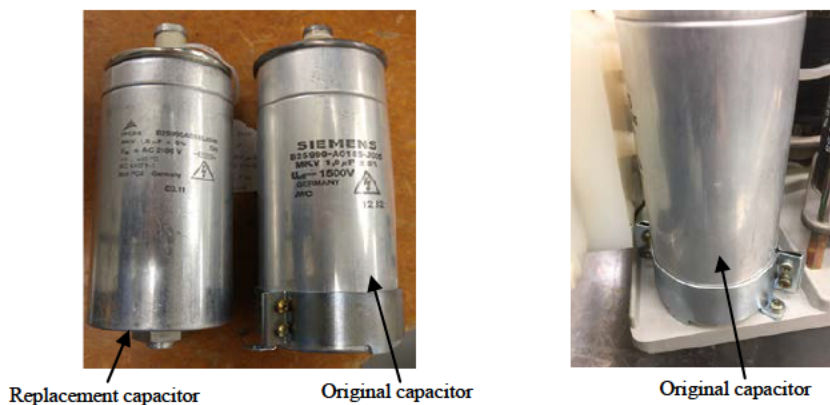
The grading capacitors are not of concern in the terms of capacitance. The heat generated by the leakage currents is much less than 0.2W, which would unlikely cause any damage to the capacitors. The other effect of the leakage currents, if any, is unknown at this point.

Figure 3.16. Comparison of original and possible replacement grading capacitors.

The failure of an oil filled grading capacitor may result in catastrophic fire. It may be prudent to replace the capacitors exhibiting significant leakage currents. Effort has been made at Dorsey to find compatible replacement capacitors. Shown in Figure 3.16 is one of the possible replacement capacitors recently purchased from Siemens (P.O. 194757). They have a different physical style than the original ones, but can be installed with minor modifications.

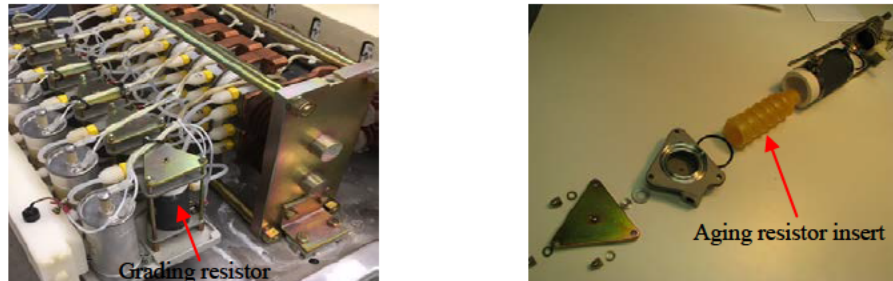
Figure 3.17. Stage 2 grading capacitor and resistor.

The plastic inserts of the stage 2 grading resistors were found to have severely deteriorated as evidenced by discoloration shown in Figure 3.17. The concern is that they would deteriorate to a degree such that they break apart and block the associated DIW cooling circuits, which could cause damage to the associated thyristor module components and even cause fire.

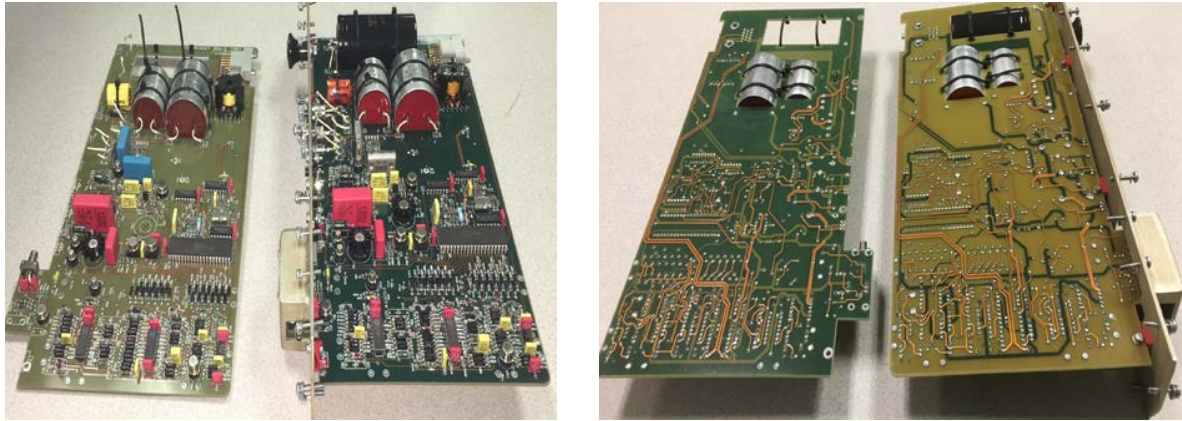
The thyristor gate units (i.e. gate electronics unit) in the P1 valves have not shown any sign of aging (see Figure 4.2).

Figure 4.2. Two gate electronics units (PCB 1561). One is scrapped and other has been repaired. They exhibit no sign of aging.

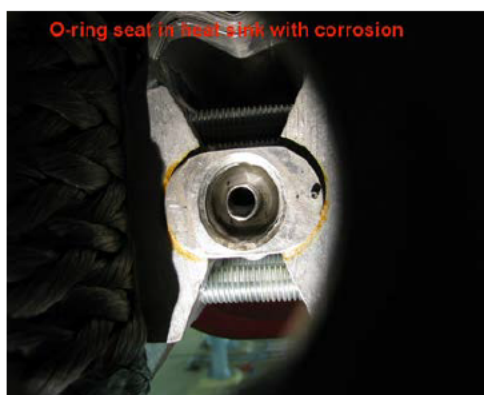
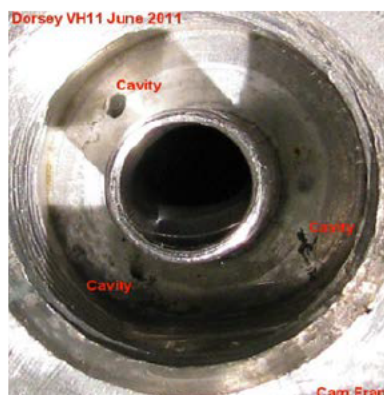
The rubber O-rings have lost their elasticity due to aging and no longer been able to seal water effectively, thus causing heatsink corrosion at some thyristor levels. Figure 4.6 shows corrosion observed in a few heatsinks at Dorsey. The deepest corrosion is about 1mm. At Radisson, one-third of the O-rings seals have been replaced, but no apparent sign of heatsink corrosion has been observed during O-ring replacement. It is still not clear as to how many heatsinks have experienced corrosion at the two stations.

Figure 4.6. Corrosion of aluminum heatsink.

Heatsink corrosion is a serious concern. If allowed to continue, it might eventually cause heatsink failure. There is no information on how to repair heatsinks in the P1 maintenance manuals. In addition, there is essentially no spare heatsink available for replacement at either station.

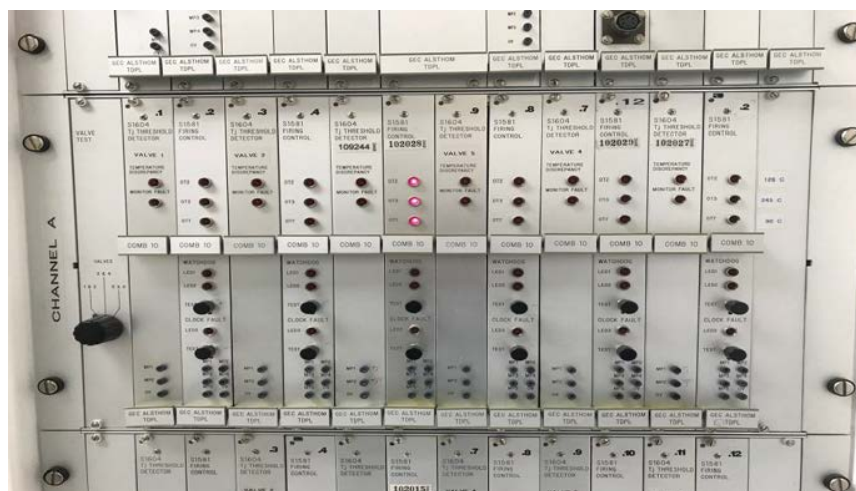
There is little knowledge, experience and support available, both internally and externally, for troubleshooting the TA&FC panel.

Figure 4.7. Mysterious fault in the TA&FC panel.

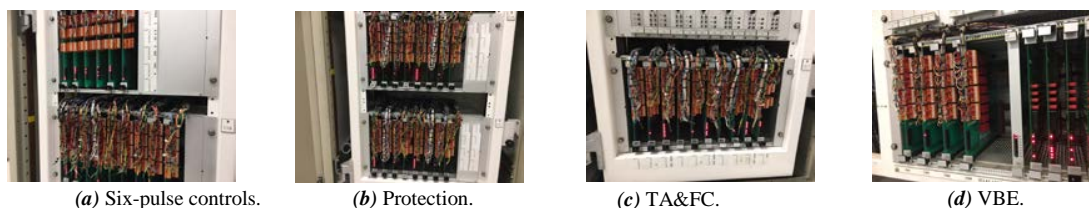
Figure 4.8. Klippon relay cards.

The Klippon relays seem to have reached the end of their life expectancy. A number of forced outages have occurred due to failed Klippon relays.

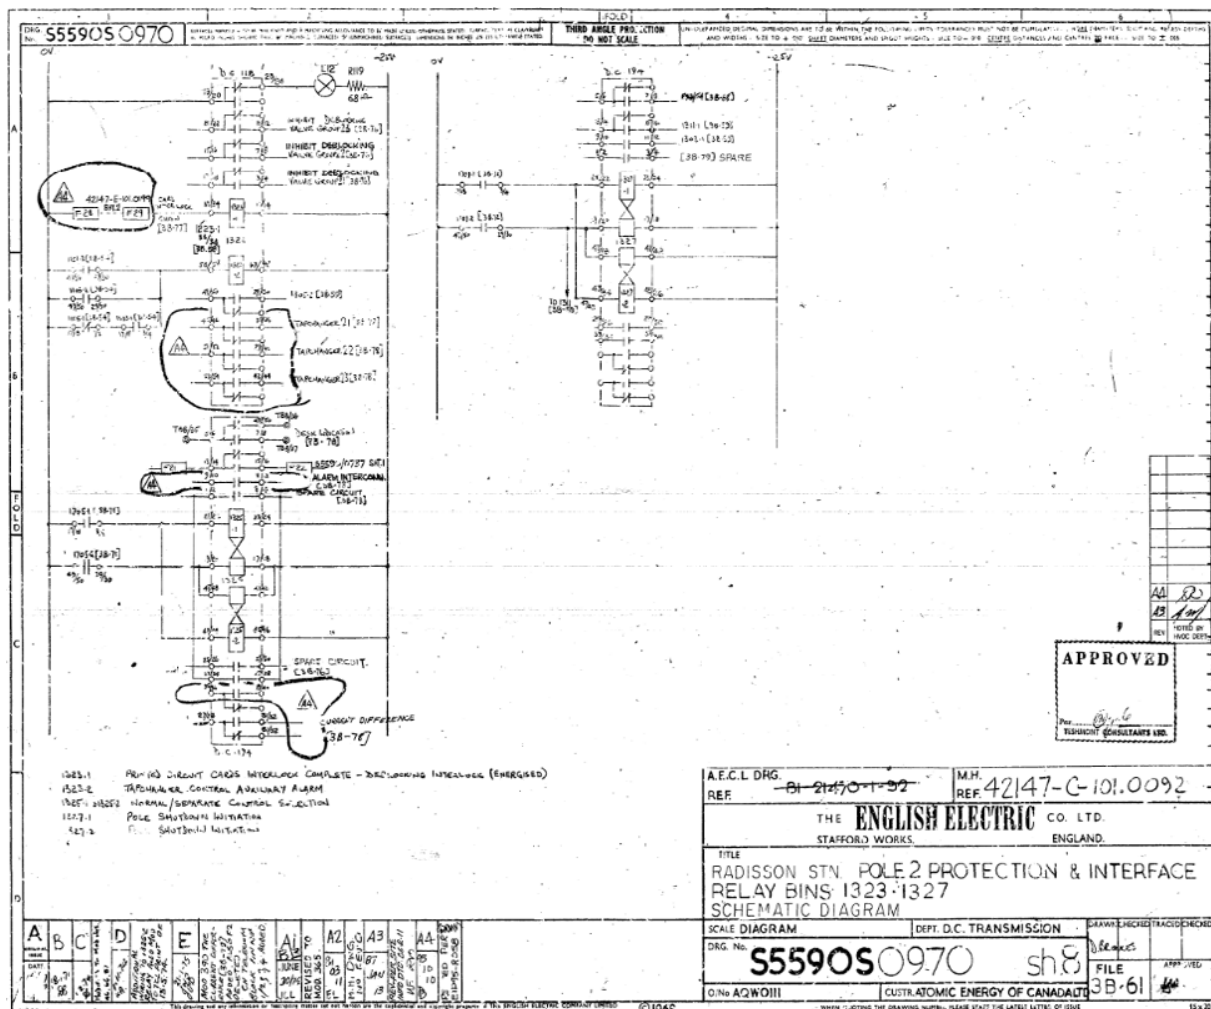
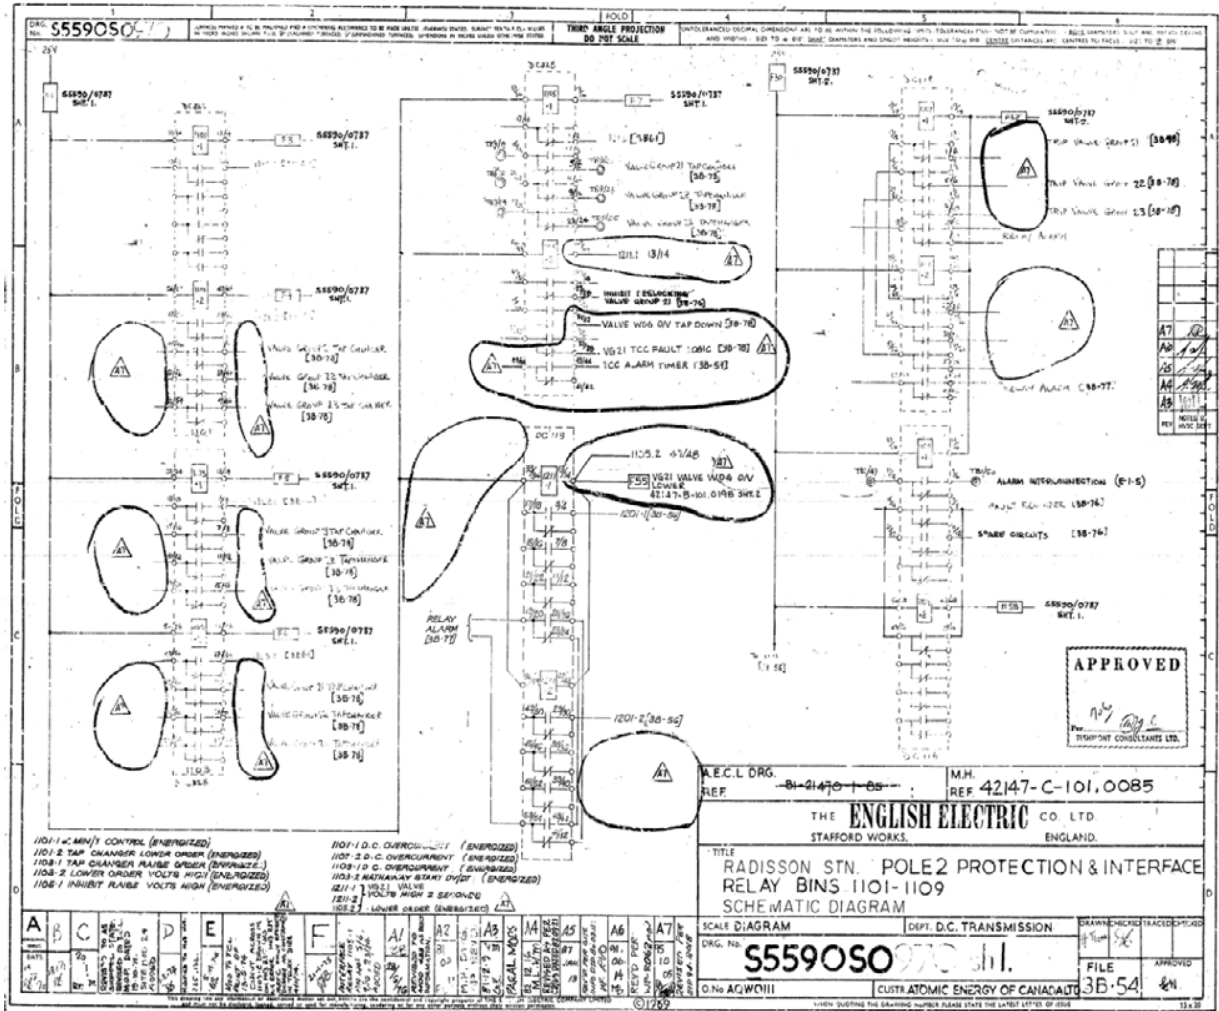
APPENDIX C: EXAMPLES OF POOR QUALITY DRAWINGS OF POLE 2

- The quality of the original equipment manuals and drawings have significantly deteriorated due to various equipment upgrades over the past few decades (see Section 5.1). Some of the drawings are not even legible (see Appendix C). This has made the associated maintenance and training more difficult.
