Please file the 2019 comprehensive condition assessment on the Bipole I and II valves and controls referenced in Appendix 7.7 (p. 9, lines 10-12).

**NELSON RIVER BIPOLES I AND II — CONDITION ASSESSMENT OF
THYRISTOR VALVES AND CONTROLS**

DATE: November 06, 2019

REPORT NO: TAM/ER – 2019/02

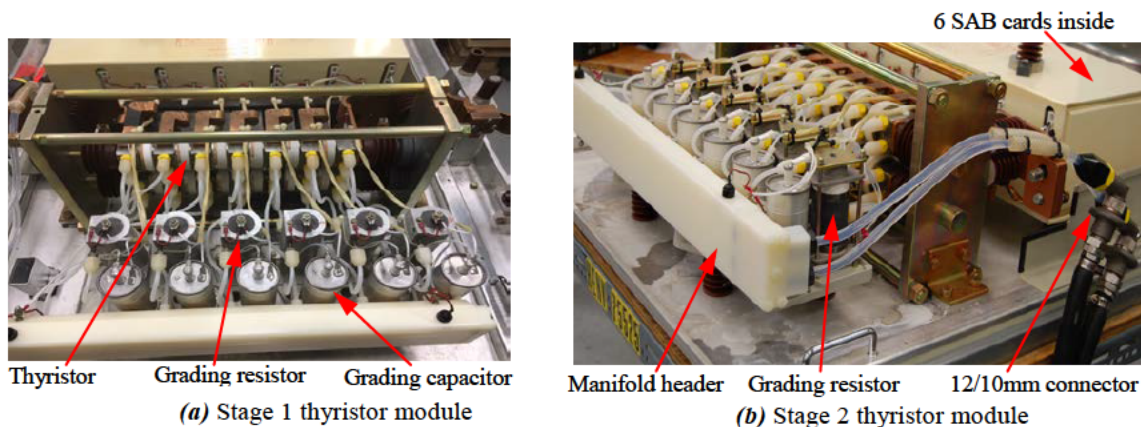
Figure 3.1. Cooling components in a thyristor module.

De-Ionized Water (DIW) was used as a cooling medium in the valve cooling circuits. What needs to be cooled by DIW includes reactor and thyristor modules. Each of them can be easily connected to or disconnected from the main tower cooling pipes through quick couplers as shown in Figure 3.1(b). Each quick coupler has a 12/10mm plastic connector.

In the thyristor modules, two types of components are water-cooled, which are thyristors and grading (or snubber) resistors (see Figure 3.1). DIW is distributed to the grading resistor and thyristor at each thyristor level through a manifold header. The thyristor modules in each VG have more than 4600 plastic tubes and 9200 plastic connectors. The existence of so many components in the cooling circuits makes the BP2 thyristor valves inherently prone to water leaks.

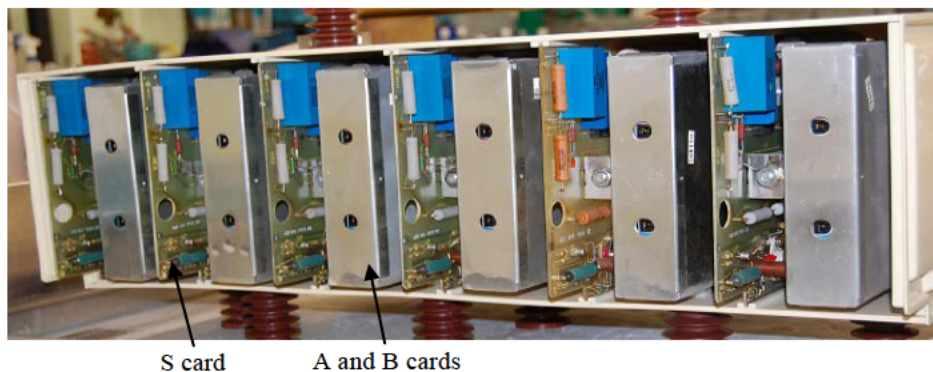
Figure 3.5. Six SAB cards in a thyristor module.

There are a total of 1536 thyristor modules in service in BP2. Each module consists of 6 parallel-connected thyristor pairs. Each thyristor pair functions as a single thyristor. The gate electronics unit for each thyristor pair is called SAB card, which includes three components: power supply board (S-card), logic board (A-card) and light transmitter & receiver (B-card) (see Figure 3.5). Totally, there are 9216 SAB cards in service in BP2.

- Fire due to SAB card failures. The failures of SAB cards have caused many fire incidents, but the resulting damage was all limited to the failed SAB cards and their neighboring cards. This is because the SAB cards are completely covered and physically isolated from other part of the thyristor module (see Figures 3.1 and 3.5). Therefore, an SAB card failure has a low probability of causing extensive damage (e.g. destroying part of a valve or VG).

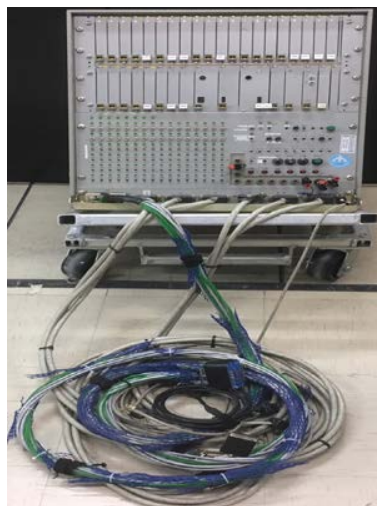
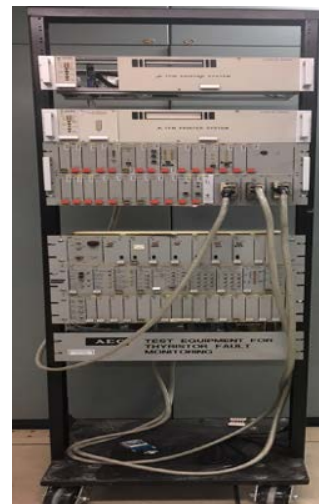
Figure 3.18. BP2 test equipment for the VBE and TFMs.

Each BP2 station has only one set of test equipment for the VBE and TFMs as shown in Figure 3.18, which has been used extensively for maintenance, troubleshooting and training purposes. The test equipment is 41 years old and in severely deteriorated condition.

If the VBE test equipment at either end fails beyond repair or becomes unrepairable due to lack of spare parts or staff expertise, it will be difficult to maintain and troubleshoot the VBE, which would result in the EOL of all BP2 VGs.

One may wonder if it is possible for the two stations to share the VBE test equipment. It is possible, but not practical for a couple of reasons. First, the test equipment is not a small/light item that can easily be shipped by air. It will be at high risk of being damaged during shipment. Second, to ship the equipment from one station to the other would take two days or much longer depending on the weather condition and the method of shipment.

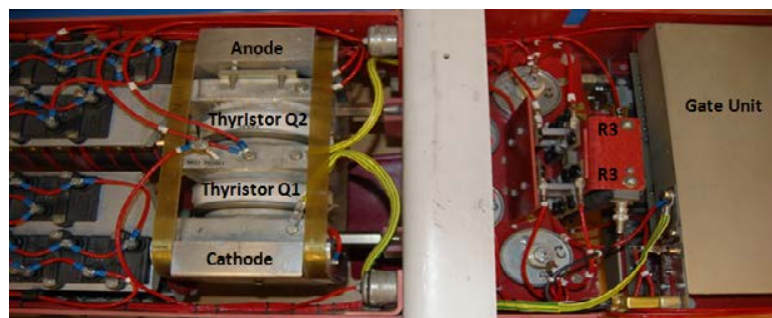
Figure 4.1. Pole 1 thyristor banded-pair assembly (or thyristor module).

The thyristor valves in P1 were constructed with 100mm Electrically Triggered Thyristors (ETT). Each valve has 42 and 40 thyristor banded-pair assemblies (i.e. thyristor modules) at Radisson and Dorsey, respectively. Each banded-pair has two thyristor levels as shown in Figure 4.1. There are a total of 2952 thyristors in service in the P1 valves at Radisson and Dorsey combined.

A damping resistor in VG12 was burnt due to a disconnected wire. The damage was limited to the resistor itself only. There is little chance for the fire to spread to the oil filled capacitors as shown in Figure 4.1.

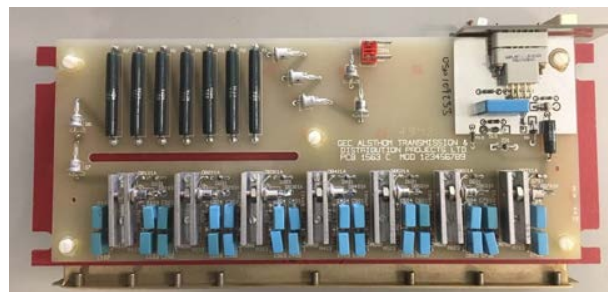
Figure 4.3. BOD card (PCB 1563).

Each thyristor level has a Break-Over Diode (BOD) card as shown in Figure 4.3. It is connected to the gate unit via a backplane (PCB1562). The BOD card consists of 7 BODs connected in series and other simple electrical components such as resistors and capacitors.

The BOD cards have been very reliable and rarely needed repairs. Like the gate units, the BOD cards have not shown an apparent sign of aging/deterioration. There are more spare BOD cards than spare gate units. Therefore, there is no concern about the spare BOD cards as well.

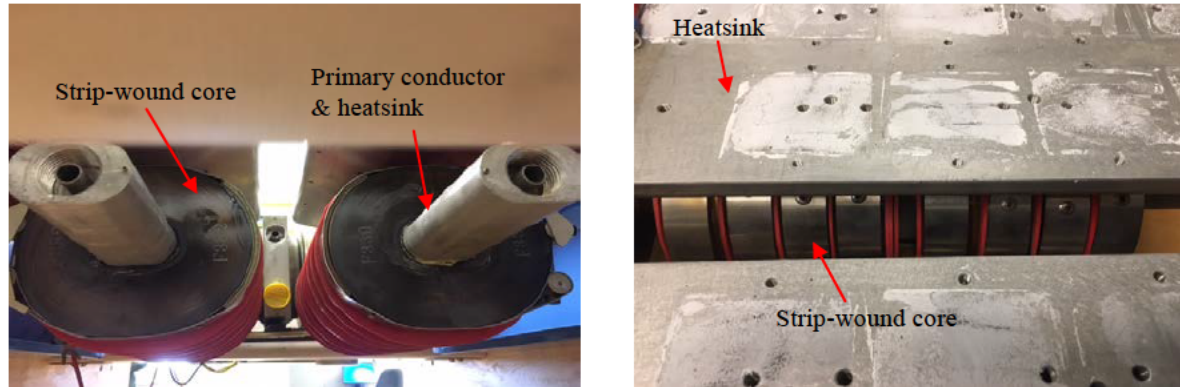
Figure 4.4. P1 thyristor level saturable reactors.

Each thyristor level has a saturable reactor that consists of 8 separate strip-wound cores as shown in Figure 4.4. There are 3 types of cores in each set: 1 of L2 cores, 5 of L3 cores and 2 of L4 cores. They are separated by silicone rubber washers.

There are 1440 and 1512 saturable reactors at Dorsey and Radisson, respectively, but there are only two spare reactors (or 16 strip-wound cores) at each station, which are being used in the thyristor test modules (i.e. banded pair assemblies).

The expected lifetime of reactors is 30 years as stated in the CIGRE HVDC life extension guides [5], which is the case with the BP2 reactor modules. The P1 saturable reactors have been trouble-free since commissioning in 1992/1993 and not yet exhibited an apparent sign of deterioration.

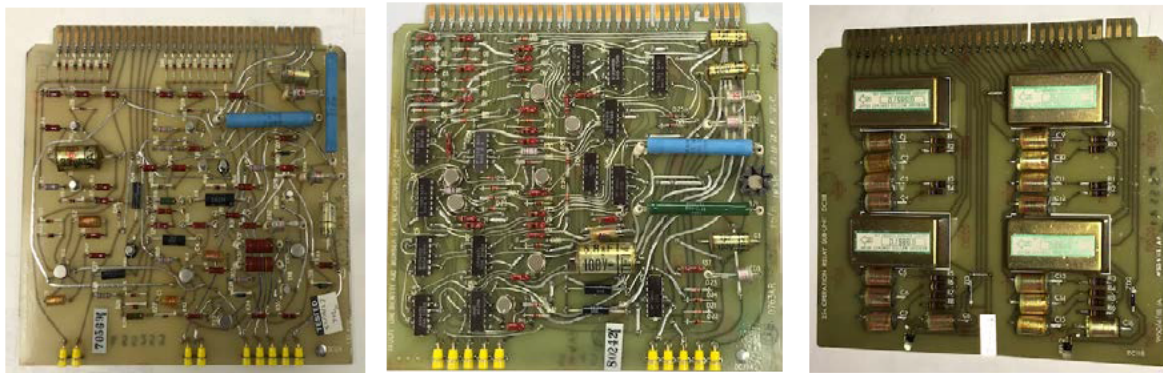
Figure 5.1. Examples of PCBs in the original analog controls in BP1.

The original analog HVDC C&P system is 48 years old, the oldest in the world. It has long passed the end of its 29 year expected lifetime (see Section 2). The analog C&P system is not redundant and any component failure in the system can cause a pole or VG outage (see Section 6.2.1).

The original pole and VG controls consist of over 750 Printed Circuit Boards (PCBs) at each station, which were built using discrete components such as resistors, capacitors, diodes, transistors, relays, etc. as well as Integrated Circuit (IC) chips, as shown in Figure 5.1. The analog controls have been modified multiple times and some cards have been rebuilt to accommodate the needs for equipment improvements/upgrades (e.g. thyristor valve replacement, bypass switch replacement, etc.). It has never been an issue to get new spare/replacement parts for repairing the controls or rebuilding cards.

However, the analog system is not only hard to understand and learn, but also difficult and time-consuming to troubleshoot (see Sections 6.1 and 6.2.1). For this reason, it is crucial to have a well-trained and very knowledgeable plant engineering workforce available at the site to perform troubleshooting during a control related outage. MH used to have such a workforce and that is the very reason why the analog system can be maintained for so many years. The workforce, however, has declined significantly since 2015 due to retirement. Without sufficient staff expertise, it is difficult to maintain the analog controls.
