PUB MFR 72 Attachment Pages 54 to 56 of 615

- a) Please update the chart showing the winter peak demand and available resources in the event of a loss of Bipoles I and II, incorporating the 2017 Load Forecast, updated DSM assumptions, and current resource availability.

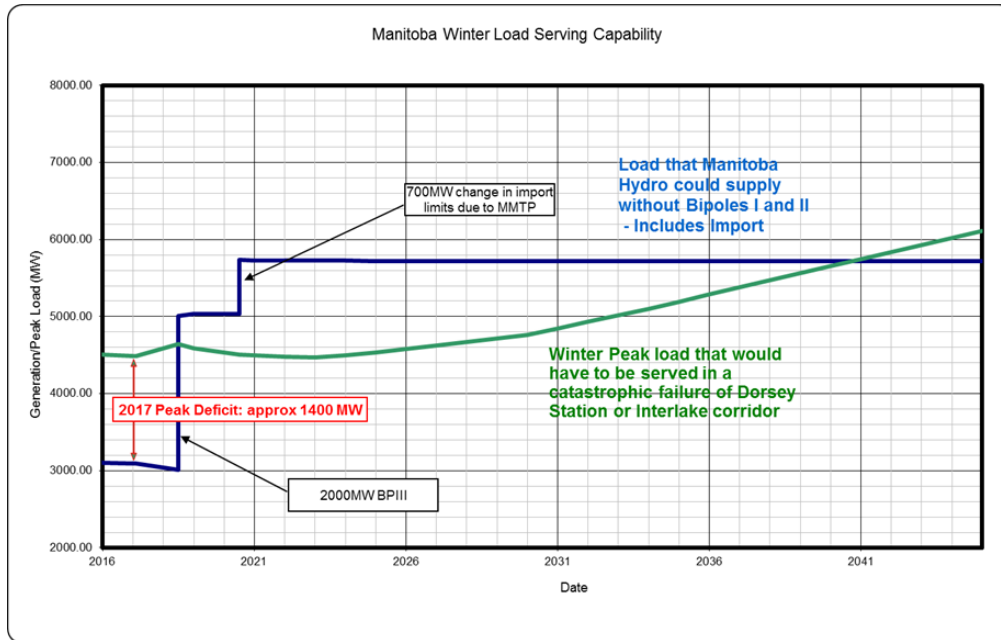
- a) The plot below shows supply-demand curves in the event of a loss of Bipoles I and II during the winter peak, incorporating the 2017 Load Forecast, updated DSM assumptions, and current resource availability.

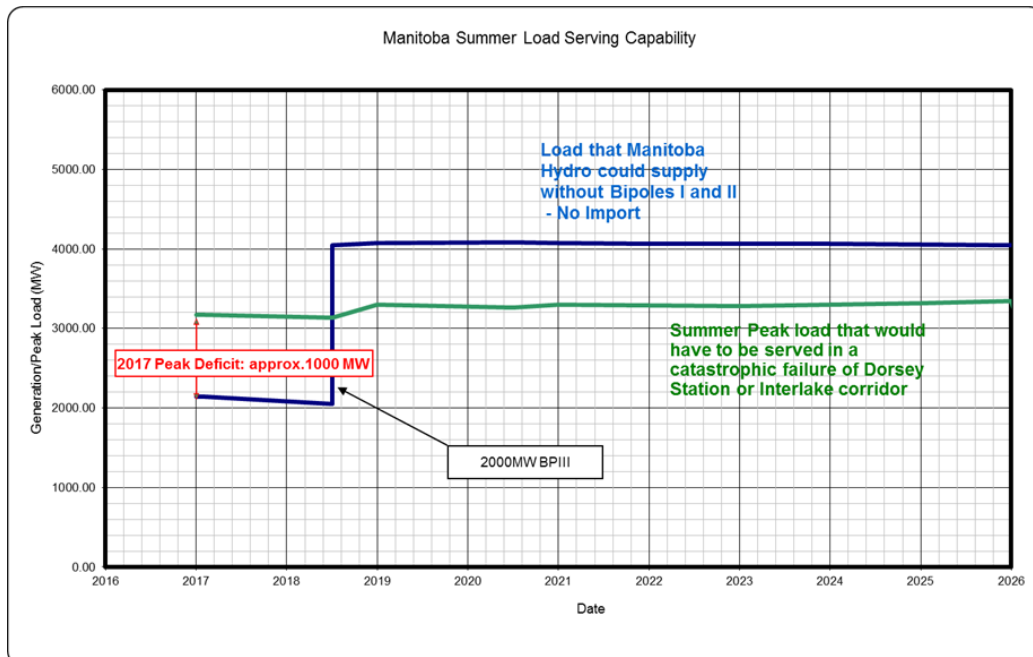
b) The plot below shows the supply-demand curves in the event of a loss of Bipoles I and II during the summer peak, incorporating the 2017 Load Forecast, updated DSM assumptions, and current resource availability. During the summer peak, there is no import available due to the unavailability of external generation resources in summer months.

- b) Please provide a similar chart as in (a) for the summer peak, including firm export commitments. If historical information is not readily available, please provide on a forward basis.
